Manhole Inspection Summary

Manhole # S45UU_022MH

Insp Date: **3/30/07 9:37 AM**

Location Address: **2831 HILLEN RD**

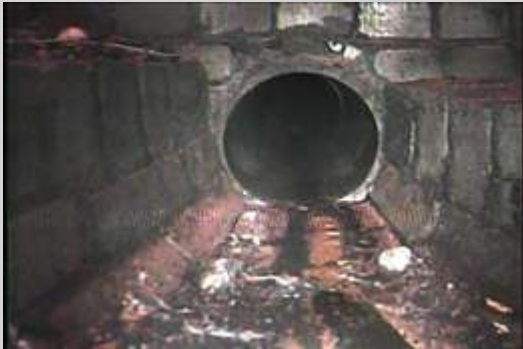
8 in. Circular Gravity Sewer Pipe Out @ 12 O'Clock

Rod and Bar (Angled)

Pipe Material: **Clay** ☐ Pipe Lined

Invert Depth: **8.84** (ft.) Flow Characteristics: **Slow**

Infiltration: **None** Pipe Seal Cond: **Unknown**

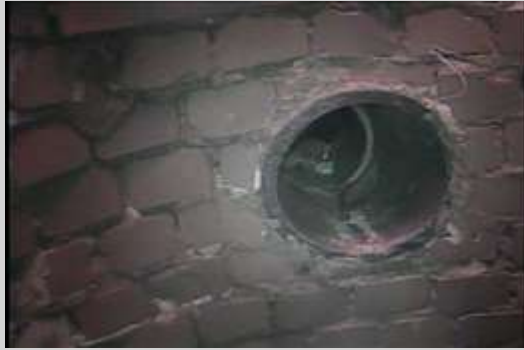
8 in. Circular Gravity Sewer

Infiltration: **None** Pipe Seal Cond: **Unknown**
